# Manhole Inspection Summary

Manhole # S45CC\_054MH

Insp Date: 7/1/08 1:26 PM

**Location** Address: **Wolfe**

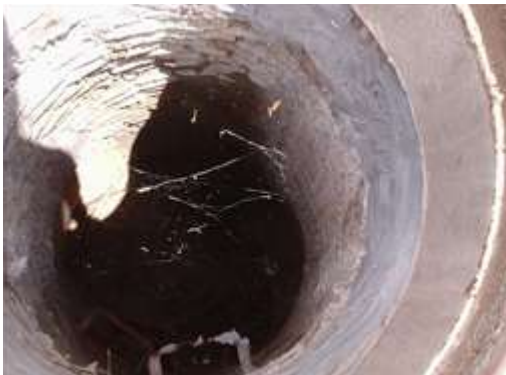
Defect 1

☒ **Leaks**

Frame Leaks

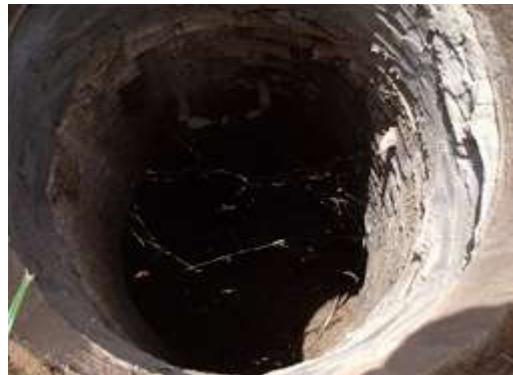
Defect 2

☒ **Wall**

Infiltration

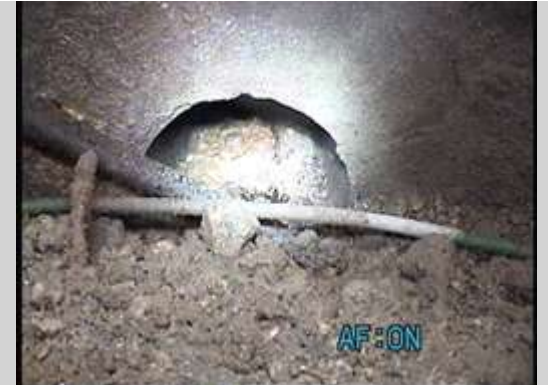
12 O'Clock Outflow

8 in. Circular Gravity Sewer  
Pipe Out @ 12 O'Clock
